RCRA SAMPLING REPORT

INSPECTION DATE: May 4, 2017

SITE NAME: Container Life Cycle Management, LLC
d/b/a Mid-America Steel Drum, Inc.

EPA ID NUMBER: WIR 000 131 367

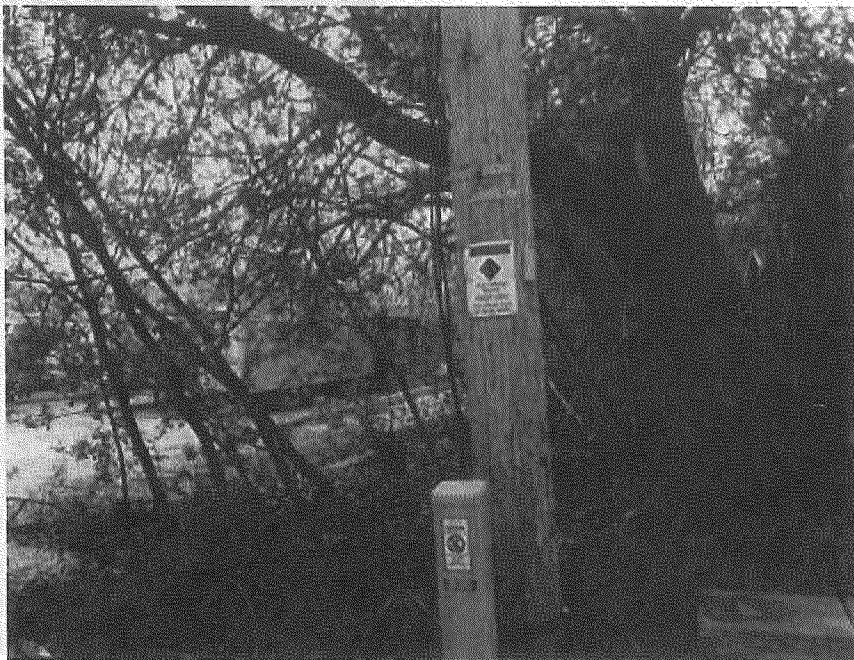
Northside dock. View from Pennsylvania Avenue. Trucks were parked at the dock where 55-gallon containers were being off-loaded.

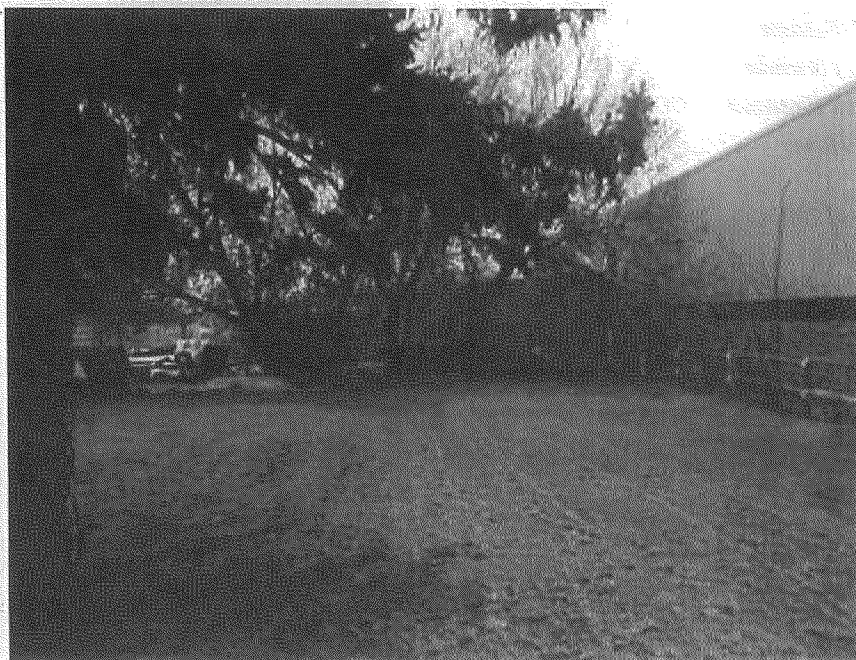
Disk Number 1
Photo Number 2
Photo Filename DSCN1062.JPG
Date/Time 5/4/2017
10:23:00 AM
Photographer Jamie Paulin

Northside dock. View from Pennsylvania Avenue. Trucks were parked at the dock where 55-gallon containers were being off-loaded.

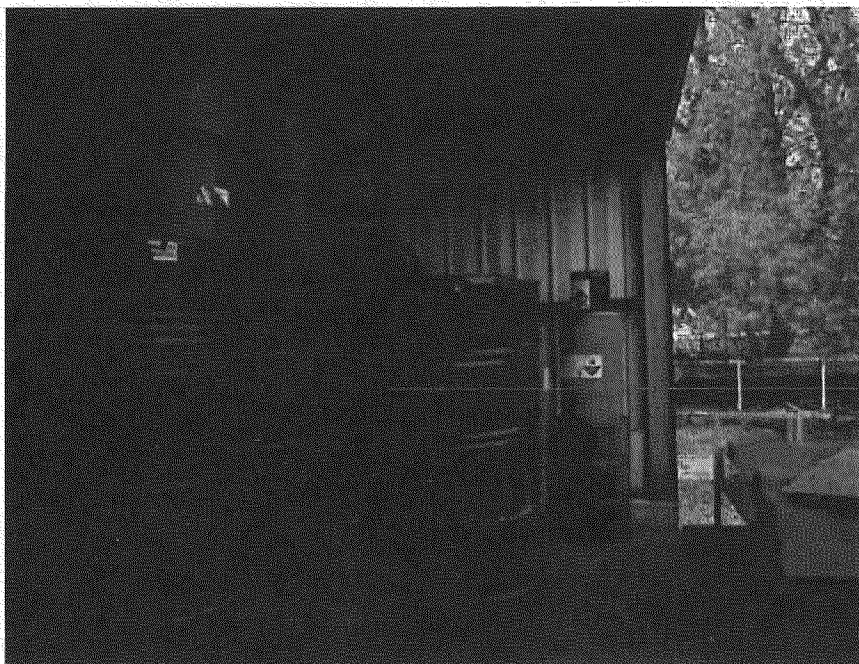
Northside Dock. Stacks of empty 55-gallon containers were being stored in this location.

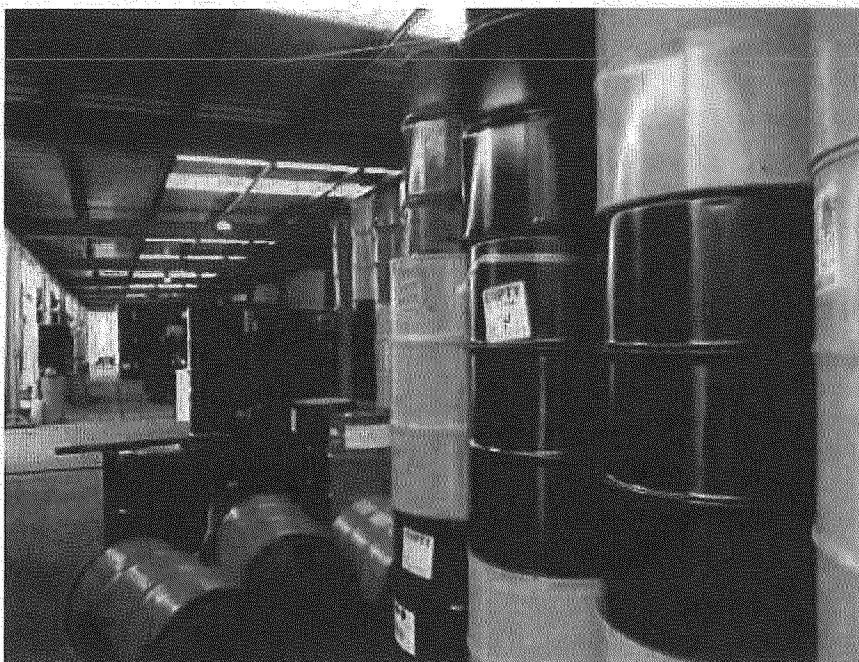
Disk Number 1
Photo Number 4
Photo Filename DSCN1064.JPG
Date/Time 5/4/2017
10:39:00 AM
Photographer Jamie Paulin

Northside Dock. Stacks of empty 55-gallon containers were being stored in this location. Some had been washed but were being rejected.

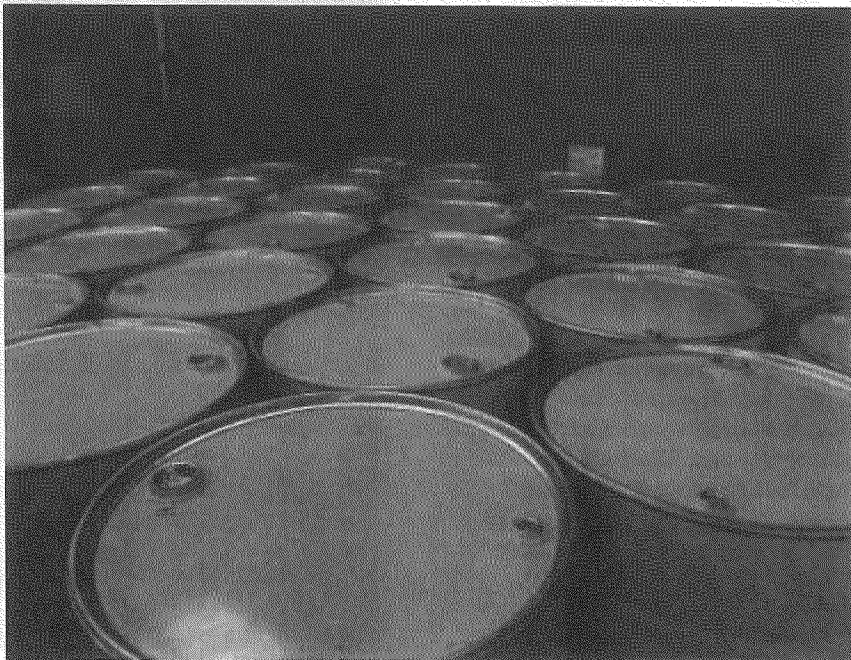
Northside dock - storage prior to conveyor belt. Several metal 55-gallon containers were being off-loaded at the time of the sampling event. These metal drums felt empty and appeared to be empty.

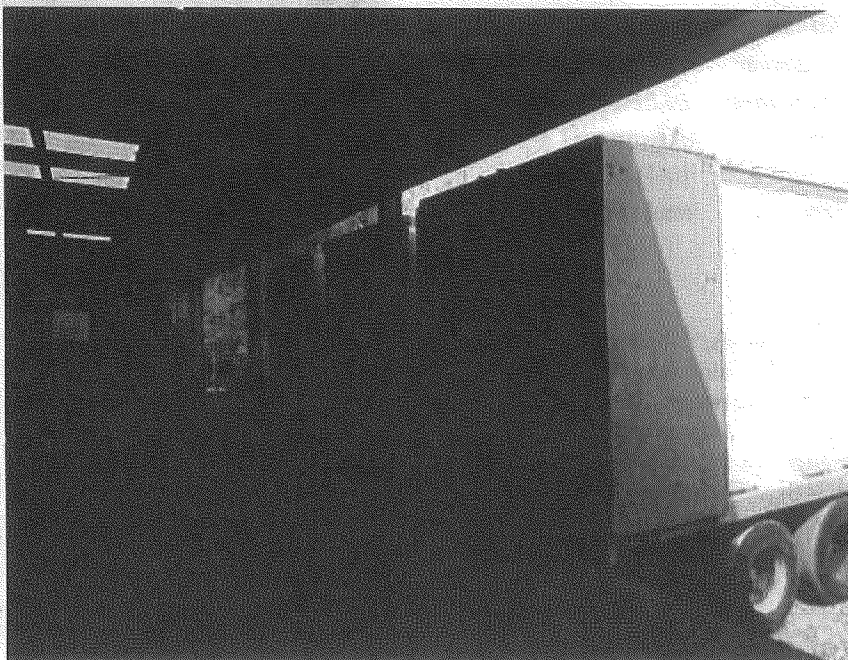
Disk Number 1
Photo Number 6
Photo Filename DSCN1066.JPG
Date/Time 5/4/2017
10:41:00 AM
Photographer Jamie Paulin

Northside dock. Several trailers of 55-gallon containers were being off-loaded at the time of the sampling event.

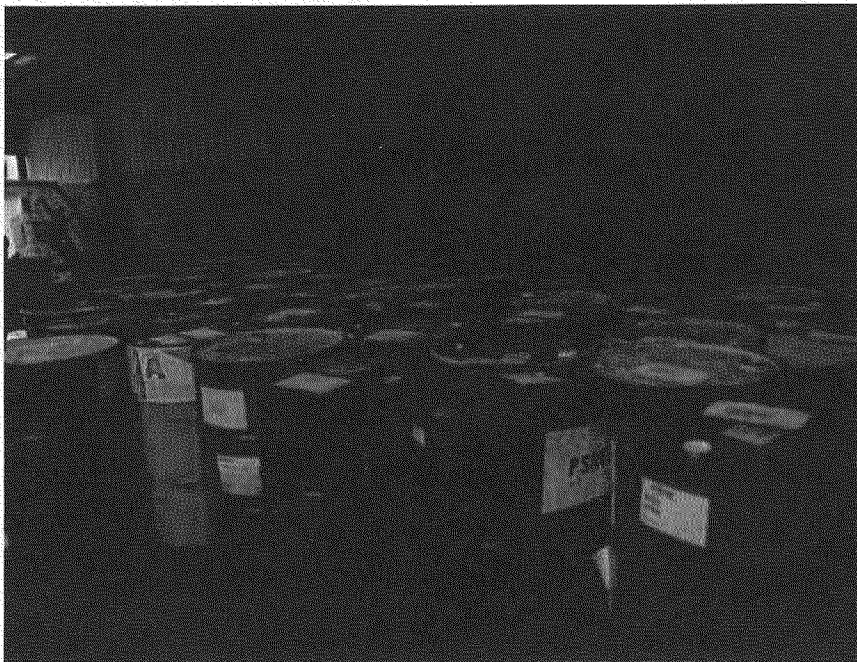
Storage of "heavies." About 103 x 55-gallon containers were being stored in this location awaiting removal from customers. There was no aisle space and it was difficult to read the assigned tag numbers. Each customer received a number assigned per drum.

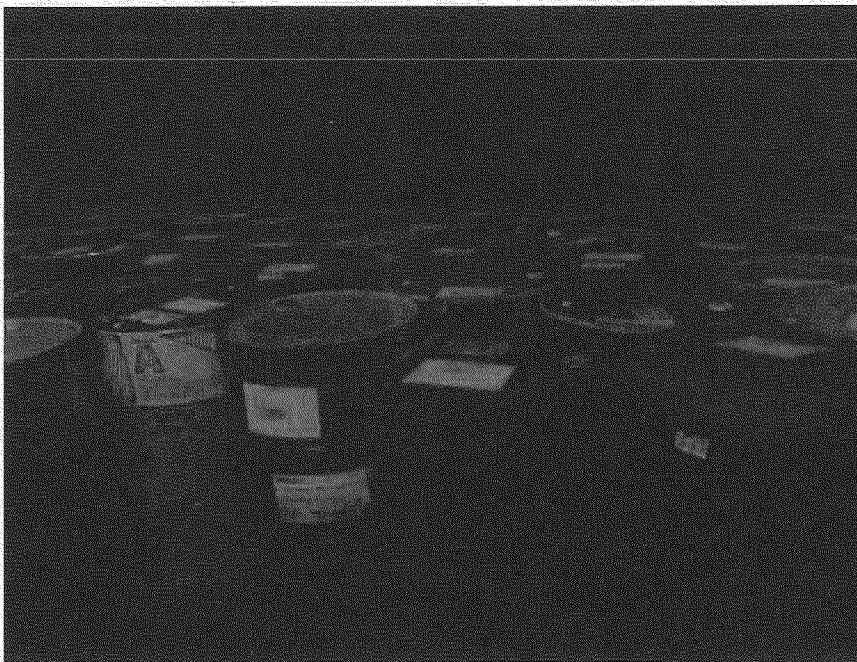
Disk Number 1
Photo Number 8
Photo Filename DSCN1068.JPG
Date/Time 5/4/2017
10:41:00 AM
Photographer Jamie Paulin

Storage of "heavies." About 103 x 55-gallon containers were being stored here awaiting removal from customers. There was no aisle space and it was difficult to read the assigned tag numbers. Each customer received a number assigned per drum - yellow tag.

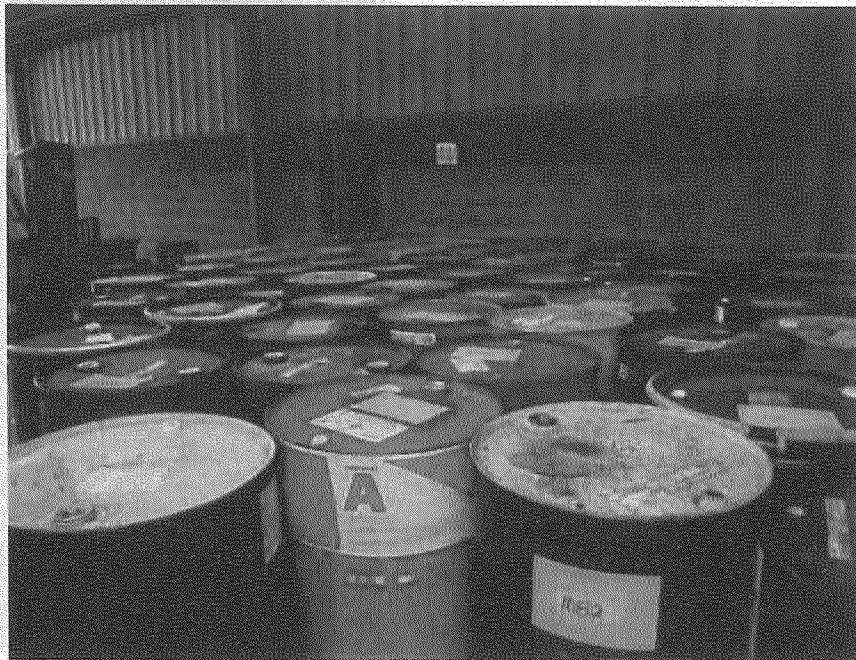
Storage of "heavies." About 103 x 55-gallon containers were being stored here awaiting removal from customers. There was no aisle space and it was difficult to read the assigned tag numbers. Each customer received a number assigned per drum - yellow tag.

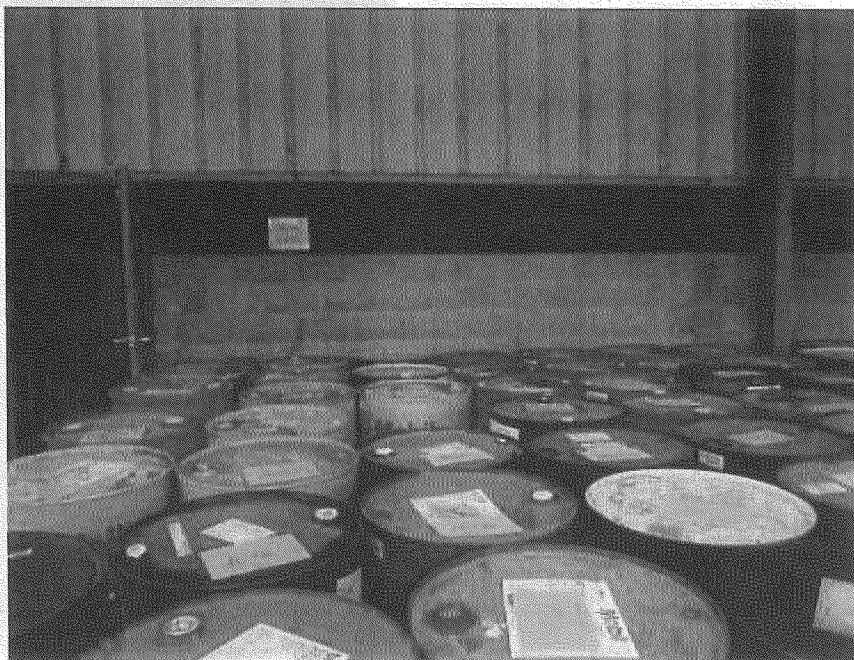
Disk Number 1
Photo Number 10
Photo Filename DSCN1070.JPG
Date/Time 5/4/2017
10:43:00 AM
Photographer Jamie Paulin

Storage of "heavies." About 103 x 55-gallon containers were being stored here awaiting removal from customers. There was no aisle space and it was difficult to read the assigned tag numbers. Each customer received a number assigned per drum - yellow tag.

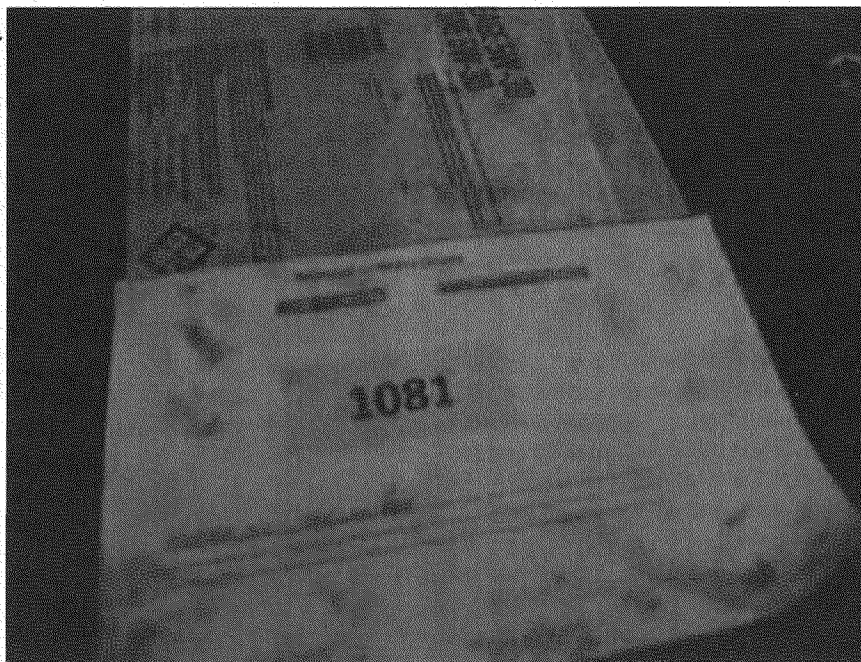
Storage of "heavies." Each 55-gallon container was assigned a tag number placed on top of each drum associated with a customer. One of the drums per tag number was dated. This tag was dated 4/28/17.

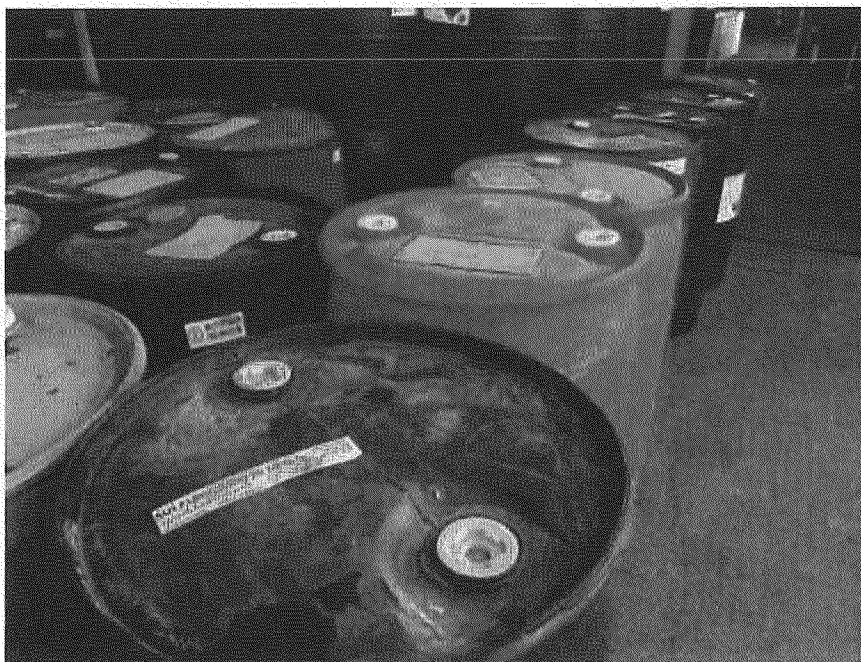
Disk Number 1
Photo Number 12
Photo Filename DSCN1072.JPG
Date/Time 5/4/2017
10:59:00 AM
Photographer Jamie Paulin

Storage of "heavies." Seven 55-gallon containers were selected from the "heavies" storage area to sample, based on hazardous material labeling. The drums were not labeled as hazardous waste nor did they contain a date. 1 did not contain a tag number label

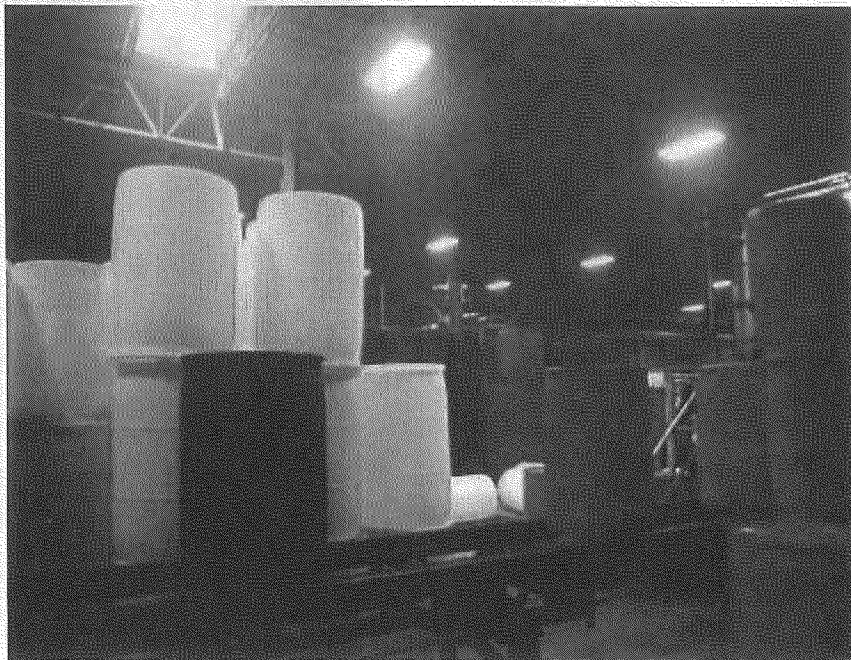
Poly drum process area. Stacks of empty poly 55-gallon containers were being loaded onto the conveyor belt for processing. The air was foggy and misty. There was a strong odor inside the facility.

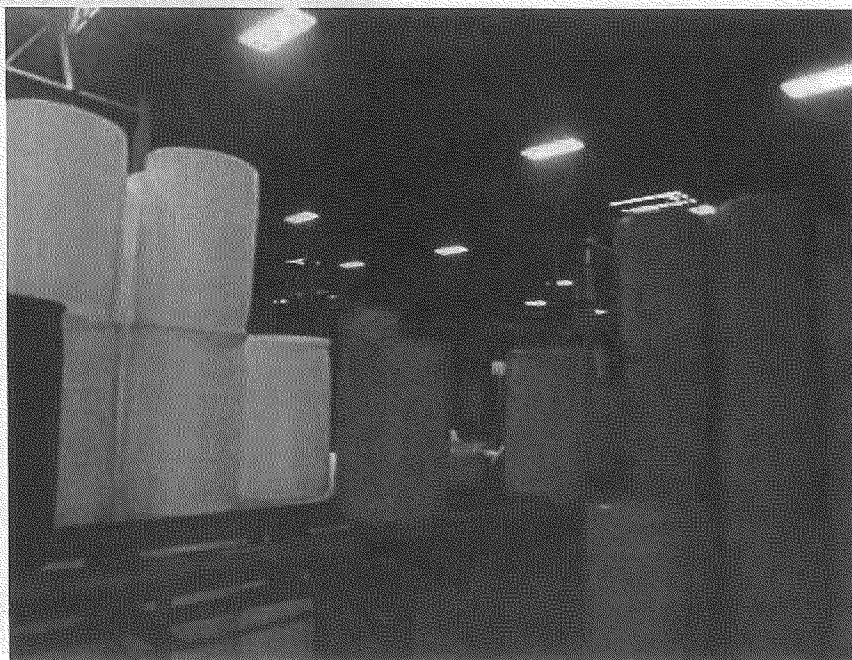
Disk Number 1
Photo Number 14
Photo Filename DSCN1074.JPG
Date/Time 5/4/2017
11:08:00 AM
Photographer Jamie Paulin

Poly drum process area. Stacks of empty poly 55-gallon containers were being loaded onto the conveyor belt for processing. The air was foggy and misty. There was a strong odor inside the facility.

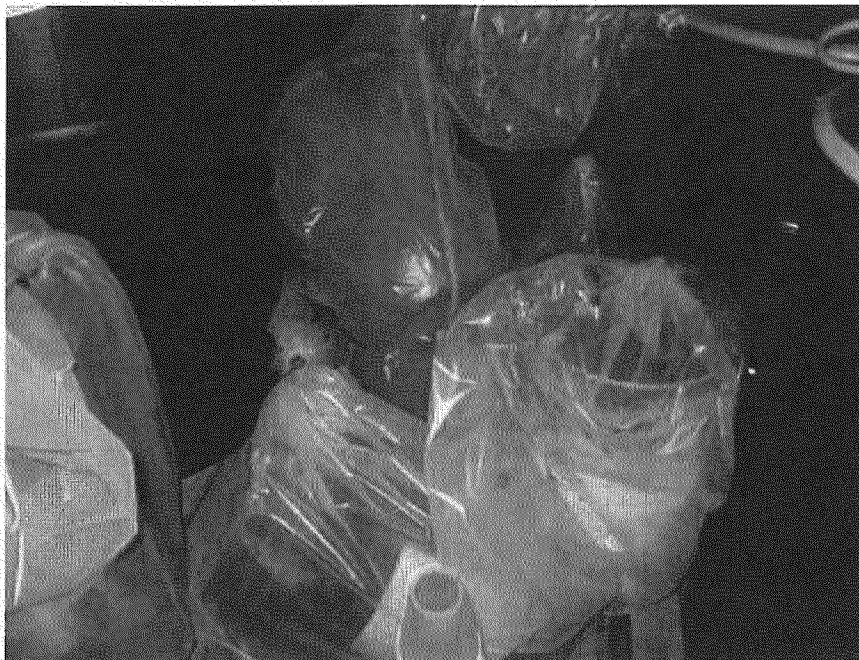
Hazardous waste storage area. Waste that had been collected by cleaning off of and under equipment was stored in 5 open buckets tied in a plastic bag with no lids, labels or dates.

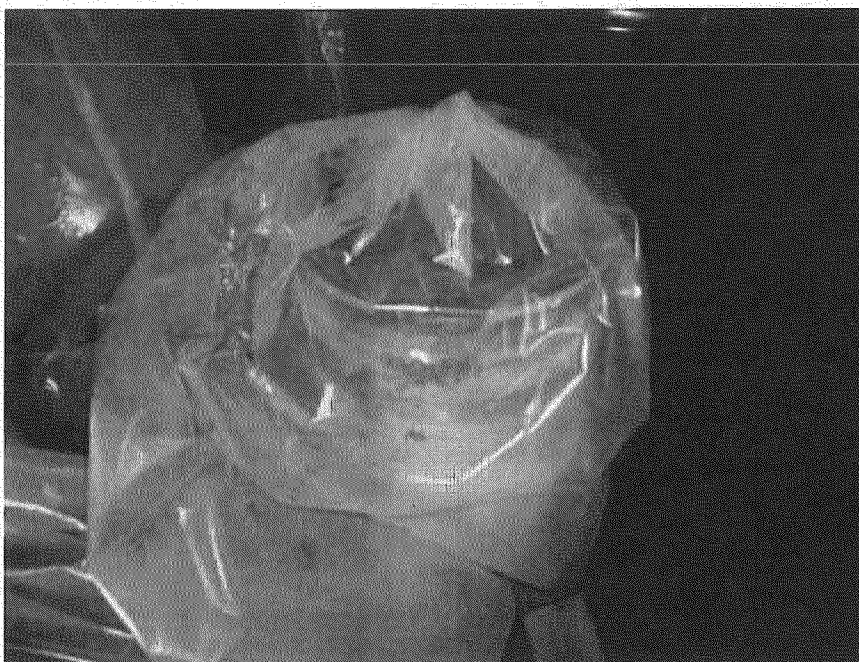
Disk Number 1
Photo Number 16
Photo Filename DSCN1076.JPG
Date/Time 5/4/2017
11:16:00 AM
Photographer Jamie Paulin

At the southeast corner of the facility we observed a hazardous waste storage area. There were 13 55-gallon drums and two 5-gallon containers marked as hazardous waste and dated. We also observed five open buckets in the area that were covered in plastic and did not appear labeled (Photographs 15 – 19). The 55-gallon drums in the area had markings on their lids which stated "Mercury Wash Water." All hazardous waste labels in the area were marked as D009 hazardous

Hazardous waste storage area. Waste that had been collected by cleaning off of and under equipment was stored in 5 open buckets. The buckets were tied in a plastic bag with no lids, labels or dates.

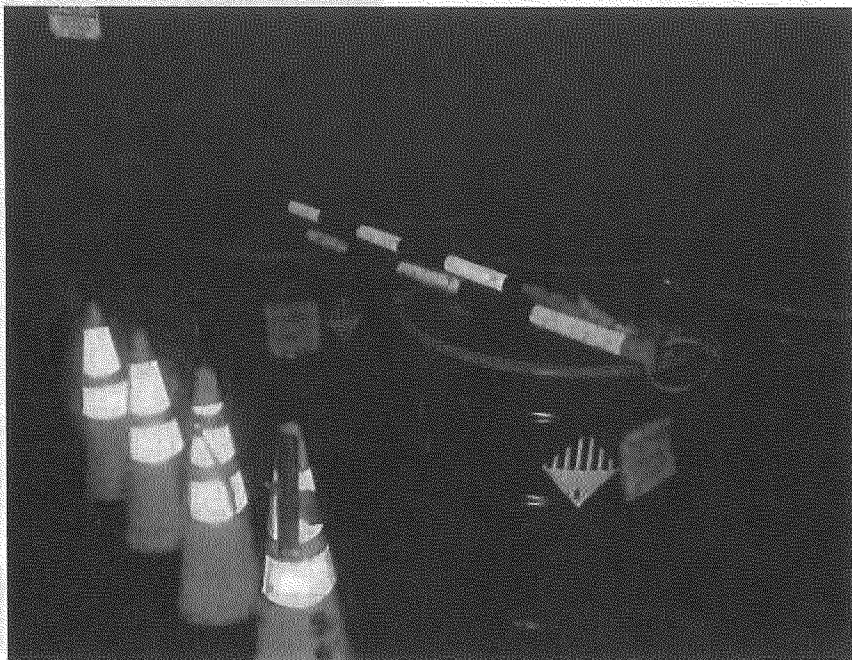
Hazardous waste storage area. 13 x 55-gallon containers and 2 x 5-gallon containers were labeled as hazardous waste and were being stored in this area. SET cleaned the equipment over the previous weekend and stored the hazardous waste in this area.

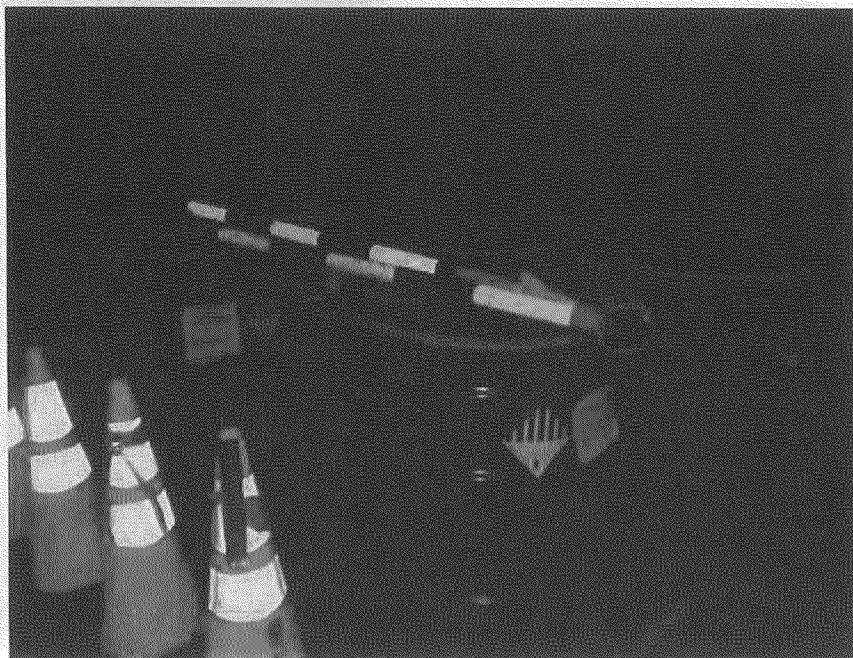
Disk Number 1
Photo Number 18
Photo Filename DSCN1078.JPG
Date/Time 5/4/2017
11:18:00 AM
Photographer Jamie Paulin

Hazardous waste storage area. 13 x 55-gallon containers and 2 x 5-gallon containers were labeled as hazardous waste and were being stored in this area. SET cleaned the equipment over the previous weekend and stored the hazardous waste in this area.

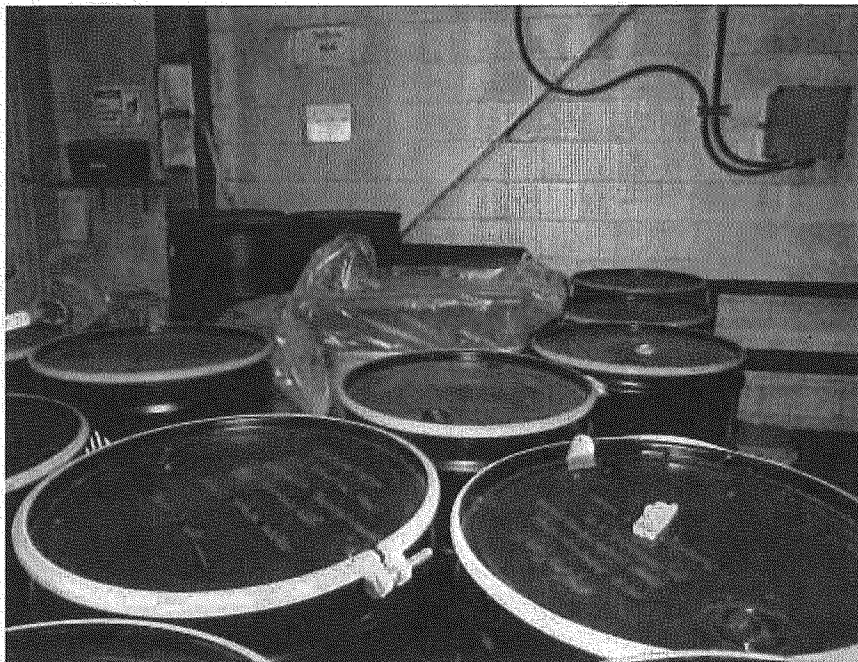
The tour continued west along the south side of the facility. We observed four large cardboard boxes across from MASD's wastewater treatment area that were labeled as hazardous waste for mercury (Photographs 20 – 21). Mr. Janowski was unsure of the source of the waste, but stated it might be filter cake from wastewater treatment operations. Adjacent to these four boxes were four 55-gallon drums that were labeled as hazardous waste for mercury (Photograph 22). One 55-gallon drum near these four hazardous waste drums had its lid marked as "Boots" (partially visible in Photograph 22). Mr. Janowski stated this drum contained the boots of MASD employees that were contaminated with mercury. This drum did not have a hazardous waste label. Another 55-gallon drum near the four hazardous waste drums was not labeled and was covered with tape (Photograph 23). Mr. Janowski stated the drum contained mercury waste. The drum was not labeled as hazardous waste.

Hazardous waste storage area. 13 x 55-gallon containers and 2 x 5-gallon containers were labeled as hazardous waste and were being stored in this area. SET cleaned the equipment over the previous weekend and stored the hazardous waste in this area.

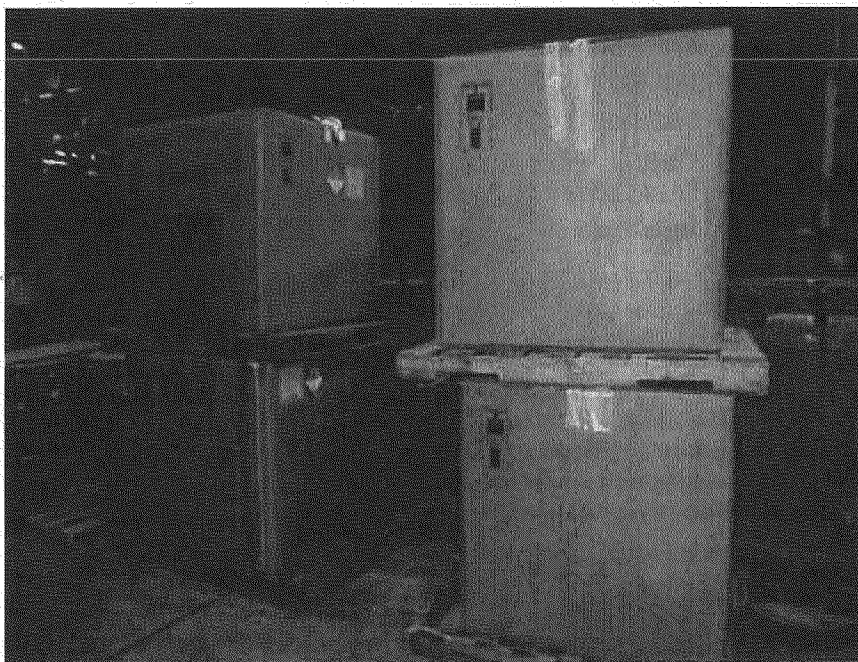
Disk Number 1
Photo Number 20
Photo Filename DSCN1080.JPG
Date/Time 5/4/2017
11:24:00 AM
Photographer Jamie Paulin

Conveyor belt located across from waste water treatment unit (WWTU) area. 4 cardboard totes were being stored with hazardous waste labels. Robert Janowski did not know the source of the waste. He stated that it might be WWTU filter cake.

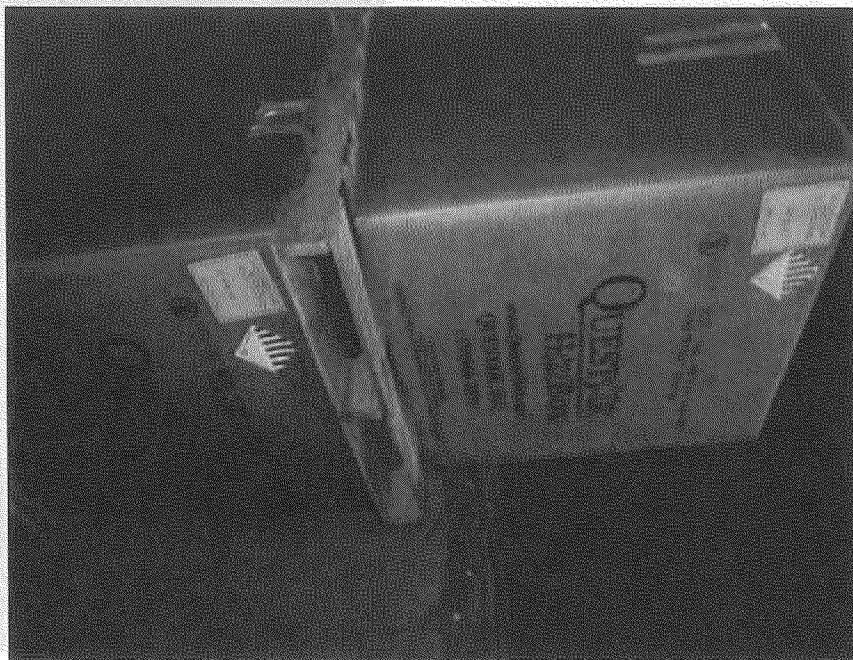
Conveyor belt located across from waste water treatment unit (WWTU) area. 4 cardboard totes were being stored with hazardous waste labels. Robert Janowski did not know the source of the waste. He stated that it might be WWTU filter cake.

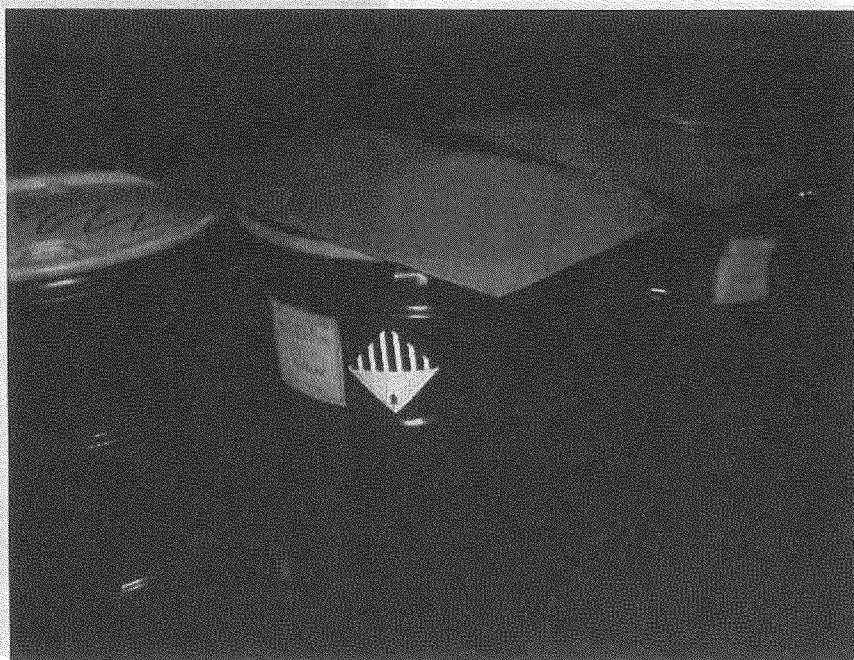
Disk Number 1
Photo Number 22
Photo Filename DSCN1082.JPG
Date/Time 5/4/2017
11:25:00 AM
Photographer Jamie Paulin

Near the process area and WWTU. 4 x 55-gallon containers were labeled as hazardous waste for mercury contamination. One 55-gallon container was storing mercury contaminated boots; however did not contain a hazardous waste label.

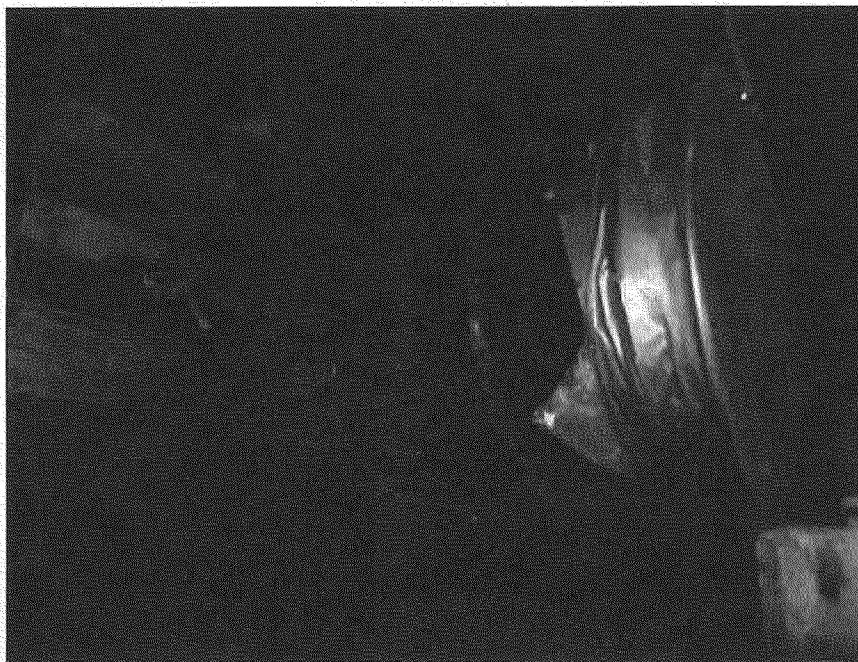
Continuing west along the south side of the facility, near the wastewater treatment area, we observed four 55-gallon drums that were labeled as non-hazardous waste (Photographs 24 – 25). Mr. Janowski stated this waste was material that had accumulated along the bottom of machinery in MASD's process line. Two of these drums were marked to be sampled.

Near the process area and WWTU. One 55-gallon container was being stored without labeling and sealed with tape rather than with a lid. Robert Janowski stated that the container was storing mercury contaminated waste.

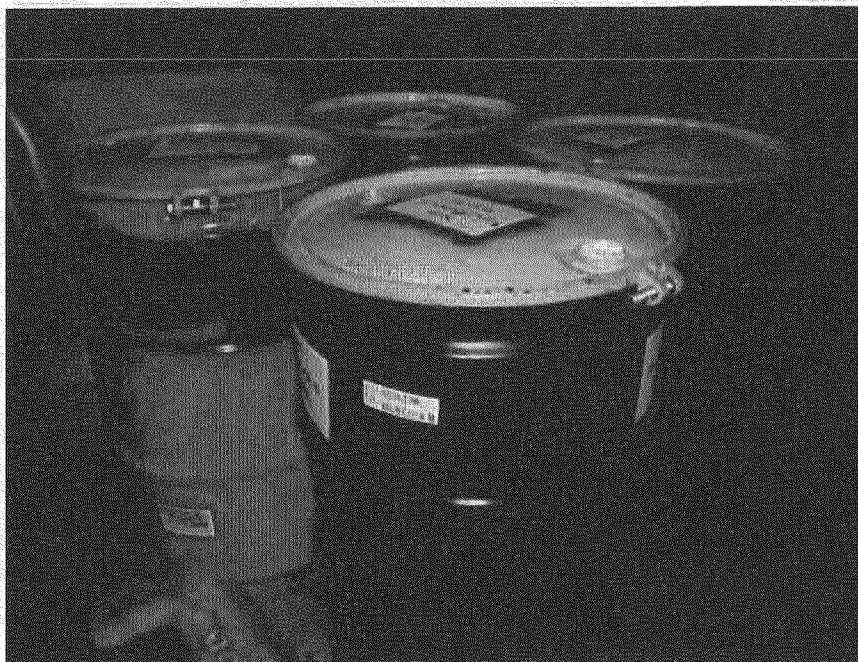
Disk Number 1
Photo Number 24
Photo Filename DSCN1084.JPG
Date/Time 5/4/2017
11:28:00 AM
Photographer Jamie Paulin

Near the process area and WWTU. Four x 55-gallon containers were being stored as non-hazardous waste. Robert Janowski stated that the waste was collected from the bottom of machinery. The drum we labeled as "H" was sampled.

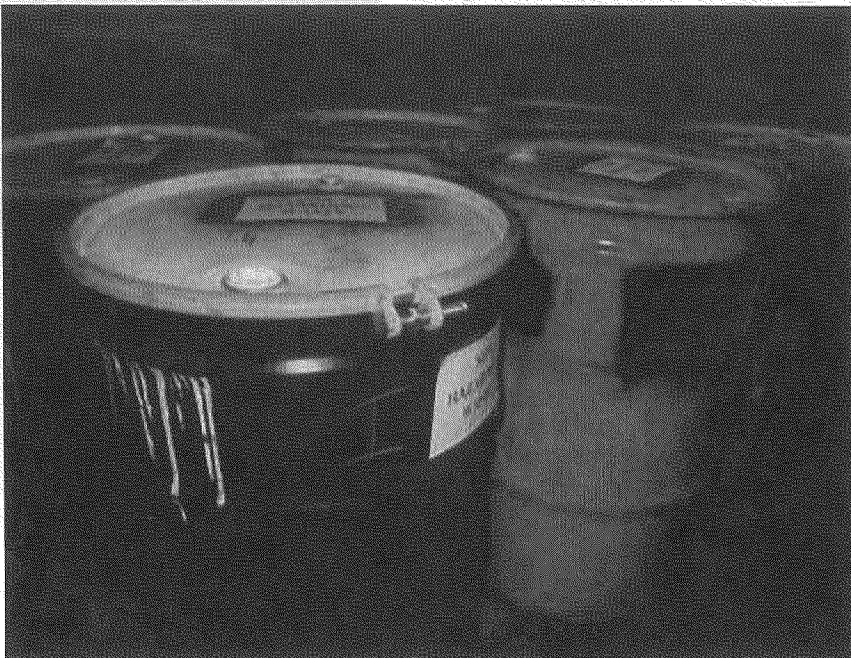
Near the process area and WWTU. Six x 55-gallon containers were being stored as non-hazardous waste. Robert Janowski stated that the waste was collected from the bottom of machinery. The drum we labeled as "I" was sampled.

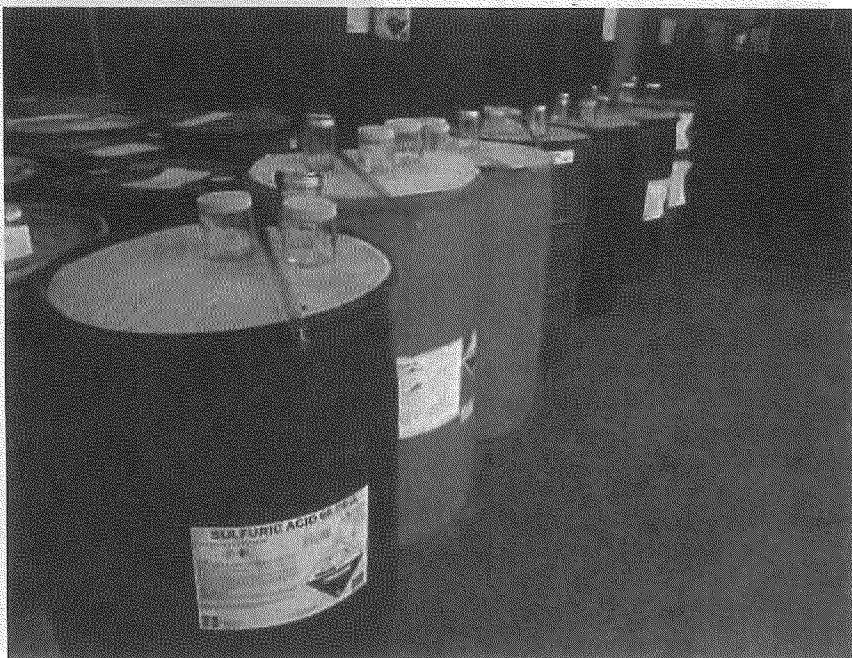
Disk Number 1
Photo Number 26
Photo Filename DSCN1086.JPG
Date/Time 5/4/2017
12:57:00 PM
Photographer Jamie Paulin

Storage of "heavies." Seven 55-gallon containers were staged and prepared to be sampled with coliwassas.

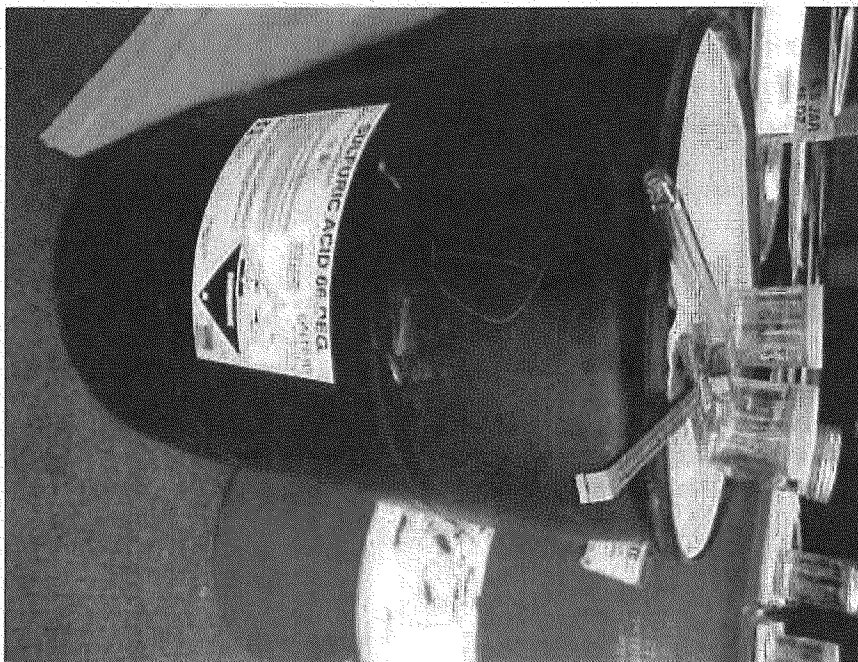
Storage of "heavies." One 55-gallon container was labeled as sulfuric acid. SFS01. Sampled 1:06pm. Level of contents was 2 inches. pH paper showed pH of 1.4 aliquots each sample jar. Split taken.

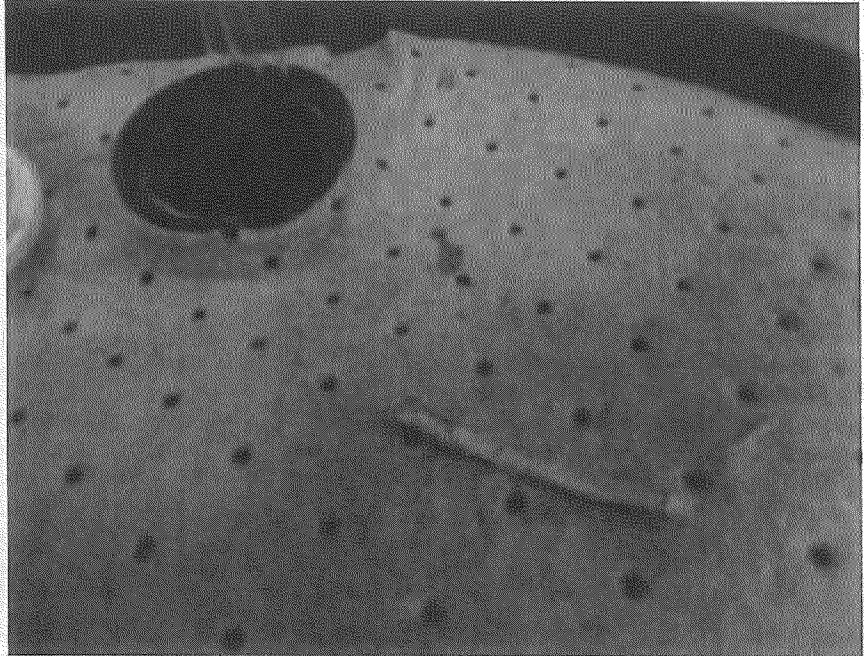
Storage of "heavies." One 55-gallon container was labeled as sulfuric acid. SFS01. Sampled 1:06pm. Level of contents was 2 inches. pH paper showed pH of 1. 4 aliquots each sample jar. Split taken.

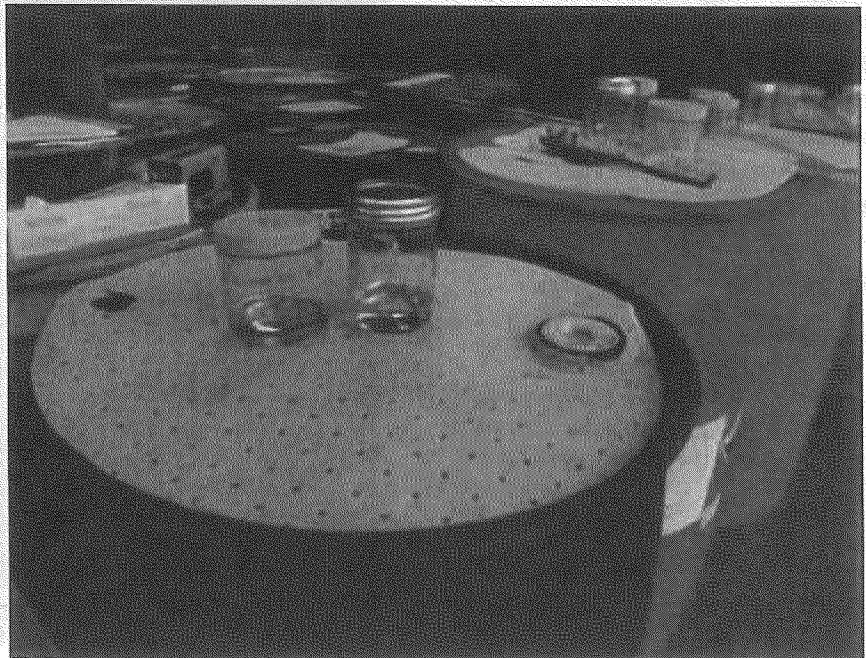
Disk Number 1
Photo Number 30
Photo Filename DSCN1090.JPG
Date/Time 5/4/2017
1:14:00 PM
Photographer Jamie Paulin

Storage of "heavies." One 55-gallon container was labeled as sulfuric acid. SFS01. Sampled 1:06pm. Level of contents was 2 inches. pH paper showed pH of 1. 4 aliquots each sample jar. Split taken.

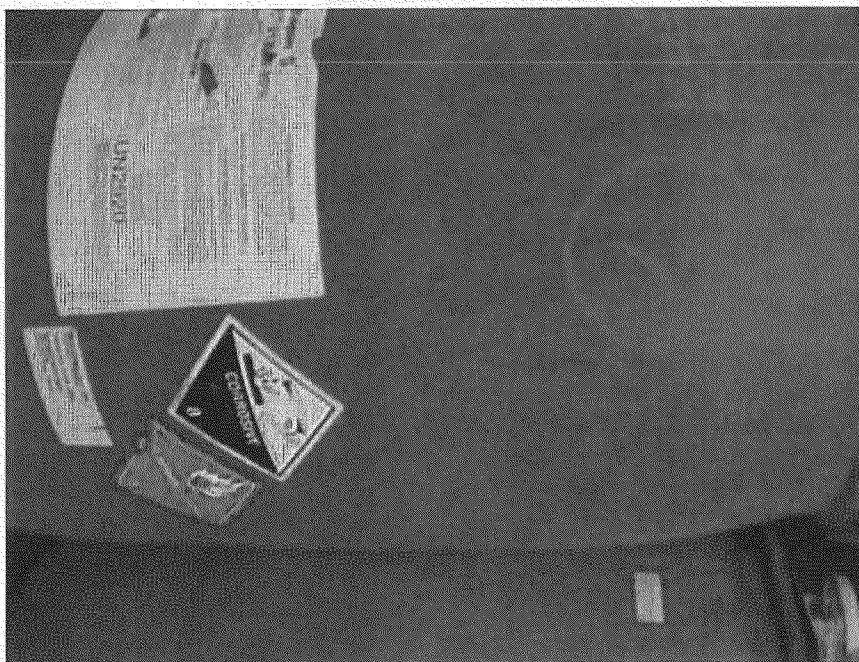
Disk Number 1
Photo Number 32
Photo Filename DSCN1092.JPG
Date/Time 5/4/2017
1:18:00 PM
Photographer Jamie Paulin

Storage of "heavies." One 55-gallon container was labeled as corrosive & flammable. SFS02. Sampled 1:20pm. Level of contents was 3 inches. pH paper showed pH of 8. 4 aliquots each sample jar. Split taken.

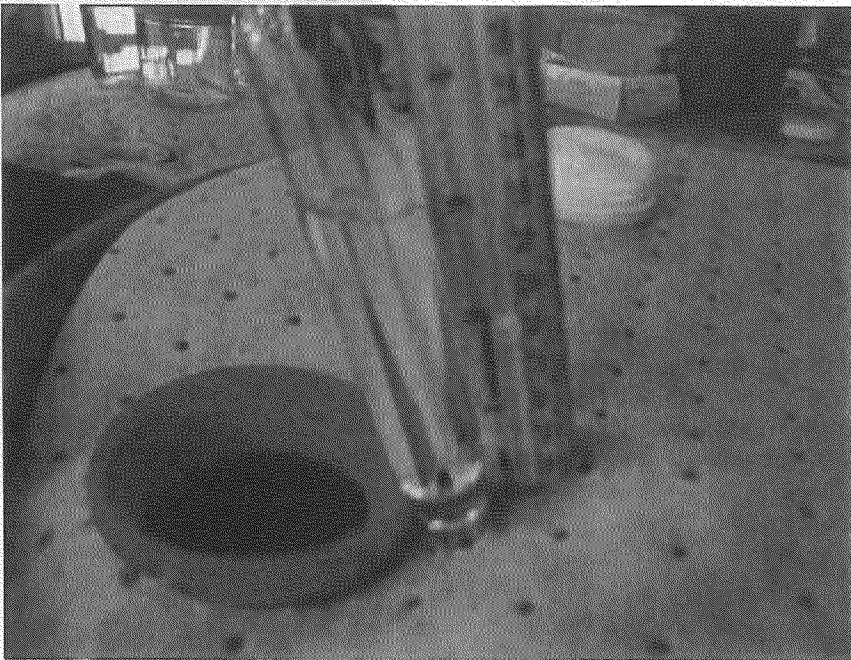
Storage of "heavies." One 55-gallon container was labeled as corrosive & flammable. SFS02. Sampled 1:20pm. Level of contents was 3 inches. pH paper showed pH of 8. 4 aliquots each sample jar. Split taken.

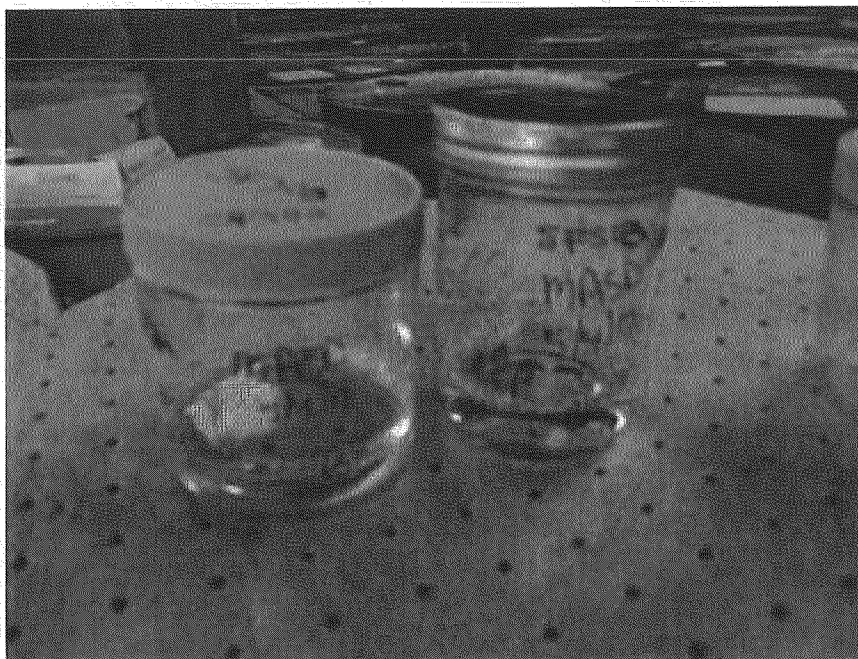
Disk Number 1
Photo Number 36
Photo Filename DSCN1096.JPG
Date/Time 5/4/2017
1:26:00 PM
Photographer Jamie Paulin

Storage of "heavies." One 55-gallon container was labeled as corrosive & flammable. SFS02. Sampled 1:20pm. Level of contents was 3 inches. pH paper showed pH of 8. 4 aliquots each sample jar. Split taken.

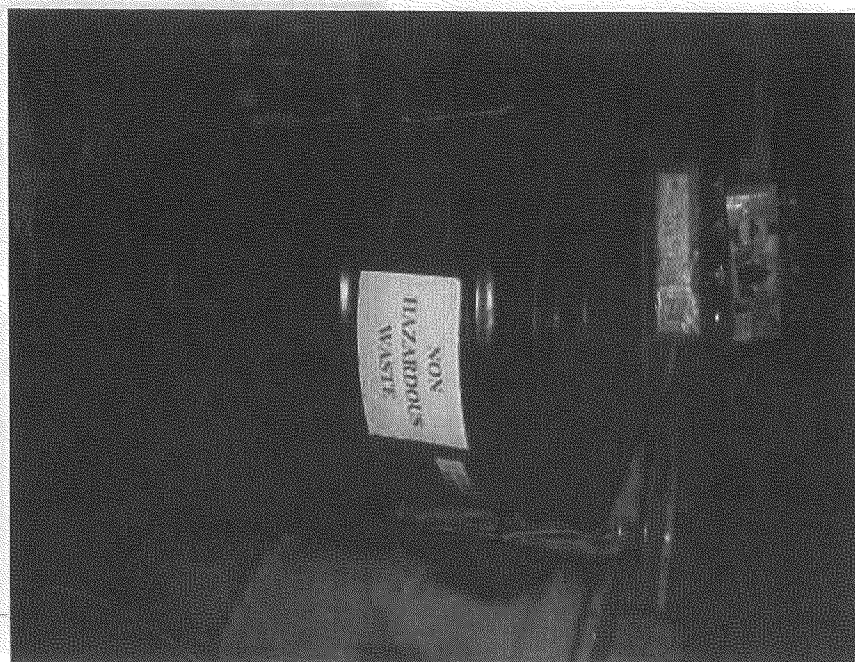
Disk Number 1
Photo Number 56
Photo Filename DSCN1116.JPG
Date/Time 5/4/2017
2:56:00 PM
Photographer Jamie Paulin

Sample No.	Time Taken (CST)	Approx. pH	Additional Observations	Photo Number
SFS08	3:10 PM	10	Black steel open-top drum marked as “Non-Hazardous Waste.” Material was brown in color with a sludgy consistency. Liquid had separated to form a thin top layer. Drum was almost full. Two full 16 oz. jars taken.	56 – 59
SFS09	3:23 PM	10	Black steel open-top drum marked as “Non-Hazardous Waste.” Material was brown in color with a sludgy consistency. Liquid had separated to form a thin top layer. Drum was almost full. Two full 16 oz. jars taken.	60 – 62

Storage of "heavies." One 55-gallon container was labeled as Non Hazardous Waste. SFS08. Sampled 3:10pm. Full contents. pH paper showed pH of 10. 8 aliquots each sample jar. 4 x 16 oz sample jars were filled. Split taken.

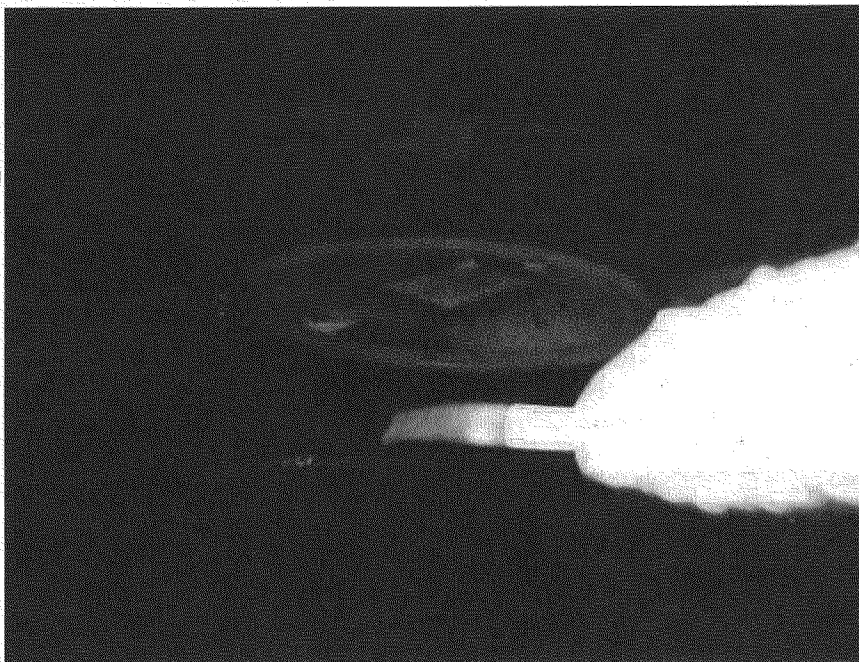
Storage of "heavies." One 55-gallon container was labeled as Non Hazardous Waste. SFS08. Sampled 3:10pm. Full contents. pH paper showed pH of 10. 8 aliquots each sample jar. 4 x 16 oz sample jars were filled. Split taken.

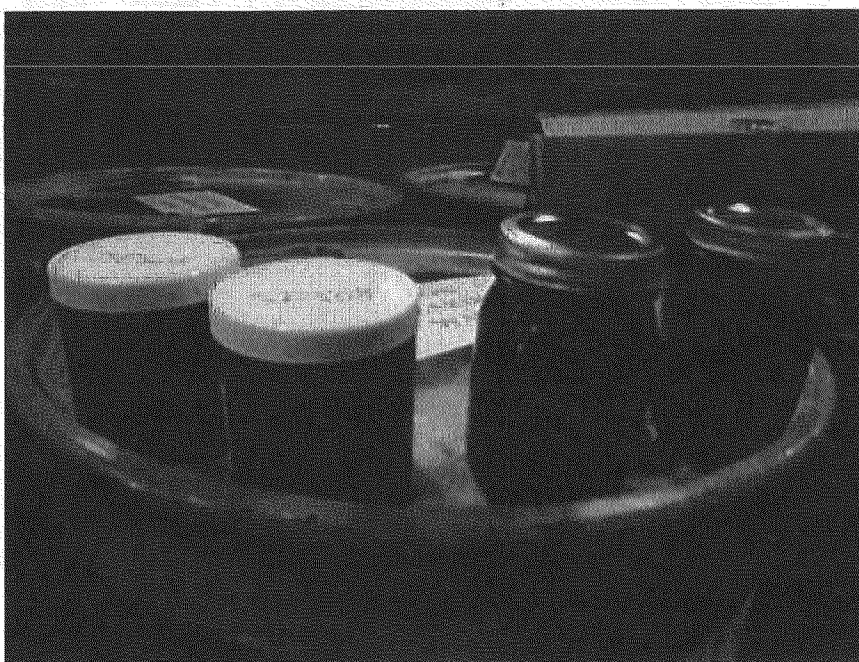
Disk Number 1
Photo Number 58
Photo Filename DSCN1118.JPG
Date/Time 5/4/2017
3:17:00 PM
Photographer Jamie Paulin

Storage of "heavies." One 55-gallon container was labeled as Non Hazardous Waste. SFS08. Sampled 3:10pm. Full contents. pH paper showed pH of 10. 8 aliquots each sample jar. 4 x 16 oz sample jars were filled. Split taken.
